Overhauling an early MG VA wet clutch gearbox

I intend this article to be a guide on how to take apart and recondition an early VA 'wet clutch' gearbox. My one is from engine number #1143, a wet clutch car. I encourage others to have a go, it is not complex but you need take care and be prepared to be patient.

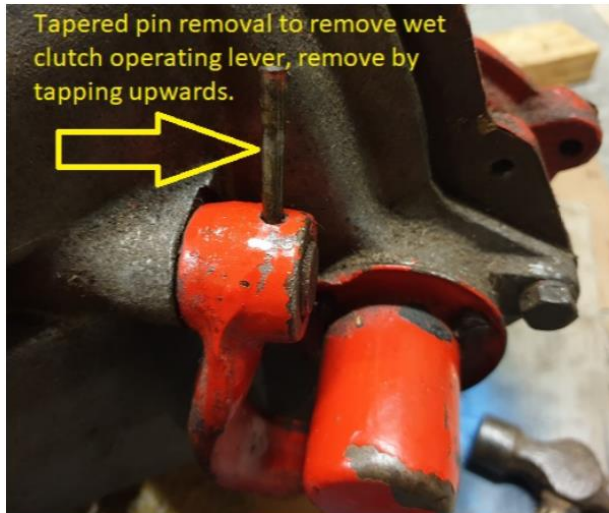
Pic 1
Remove the gearbox

The MG Instruction Manual and Blower tell you how to do this. As mine was out of the car I just had to remove it from the bell housing..... BUT with the wet clutch there is a trick, you need to operate the clutch lever up to clear the clutch bearing (I have also been told to rotate the gearbox 180 degrees but cannot recall having done that), remove the pin to remove the clutch lever, it is tapered. Tap up to remove.

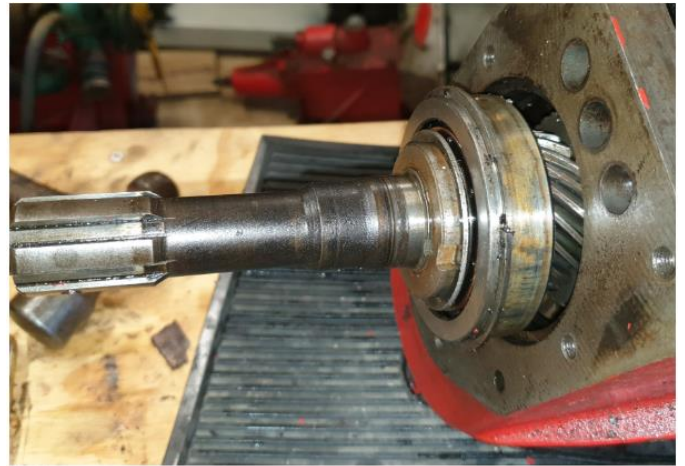
Pic 5

Success!! (the white stuff is just the paint off the label from my engineering gloves)

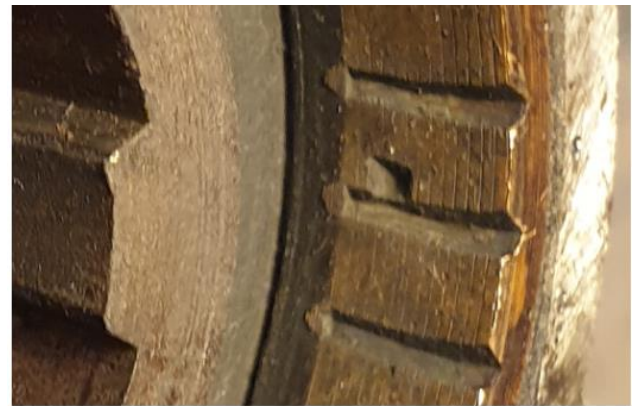
Pic 12

By way of another gearbox, the one above is very worn and should not be used!!

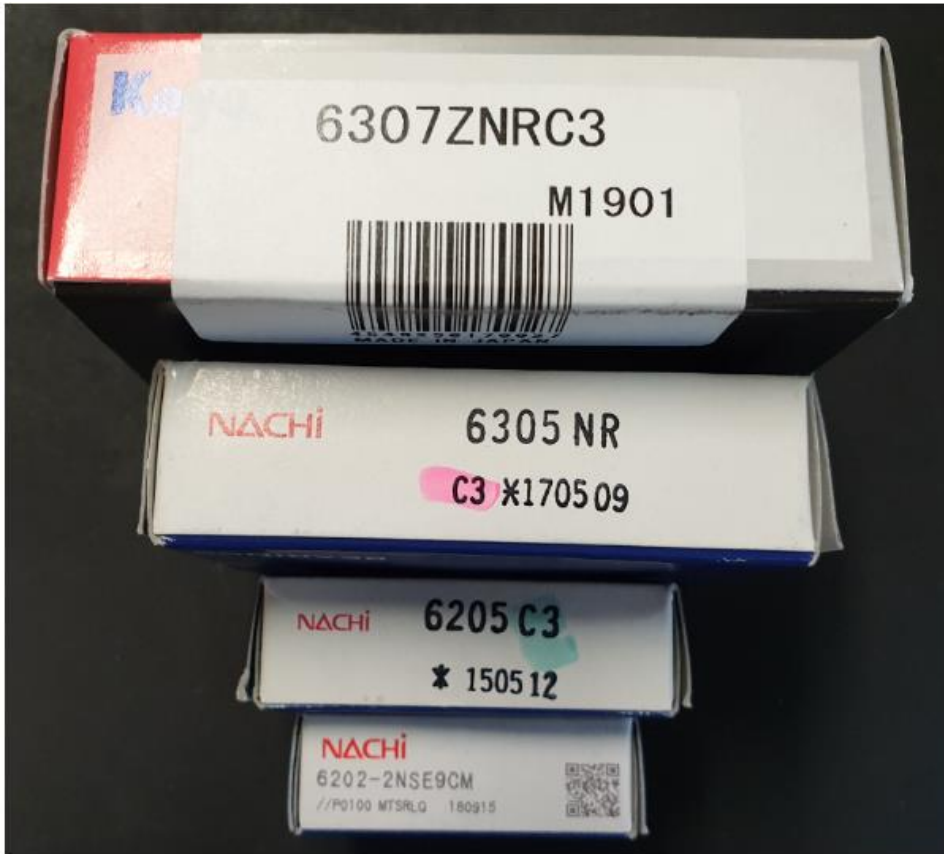
Pic 13

Even though all the three ball race bearings were in excellent condition, I decided to replace them all. I enquired and was told that modern bearing material is a lot better than the early ones so was not tempted just to leave them. Note the **C3** on the part number on the three bearings, this is a design that allows slight variations with their alignment and is **HIGHLY RECOMMENDED** for these early (inaccurate) gearboxes.

The numbers are SKF and I learned a lot about bearings and their codes. They are all available off the shelf. I thought that was odd until my bearing supplier said that about every manufacturing plant still uses them and Morris did that too, cheap and cheerful, common as muck bearings, off the shelf. I purchased all the gearbox and all six wheel bearing for under NZ\$300. He said that one modern 'specialist' car bearing alone would cost all that!

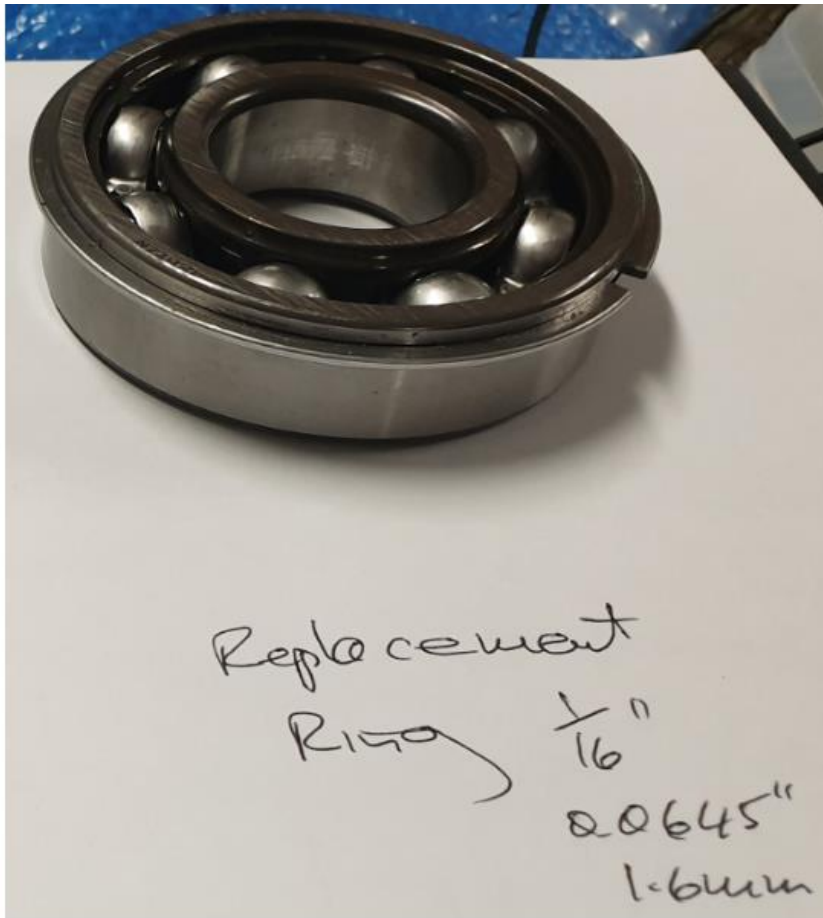
Pic 18

New snap ring as supplied on the new bearing

To our relief, the new bearing's groove was wide enough for the original snap ring so we just swapped it. Gordon had to have his bearing's groove ground out not a nice option. The difference is only 1/64" but it could have upset distances so ignore this at your peril I was told.

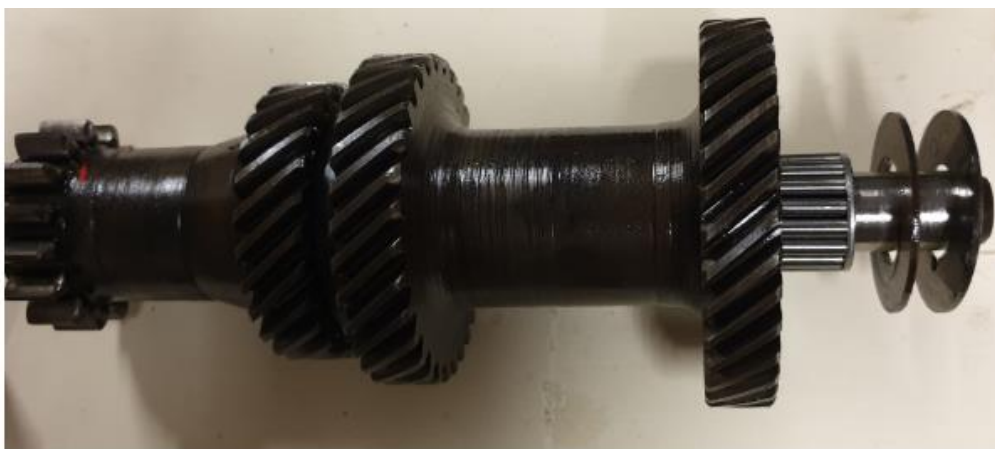
Pic 19

The original early VA caged lay shaft bearings setup looks like the Pic 19, it is easy to install as all the rollers are held in situ within the cage.

The First Motion Shaft [MG735/168] single caged bearing [MG735/176] and caged Bearing for Layshaft [MG 679/362] (one for each end) are replaced with needle rollers – all needle rollers are of the same size. 13 for the First Motion Shaft and 15 for each end of the lay shaft, total of 43 identical needle rollers. Mine were in top condition so did not replace them however I researched the part numbers and they are in Pic 20 below:

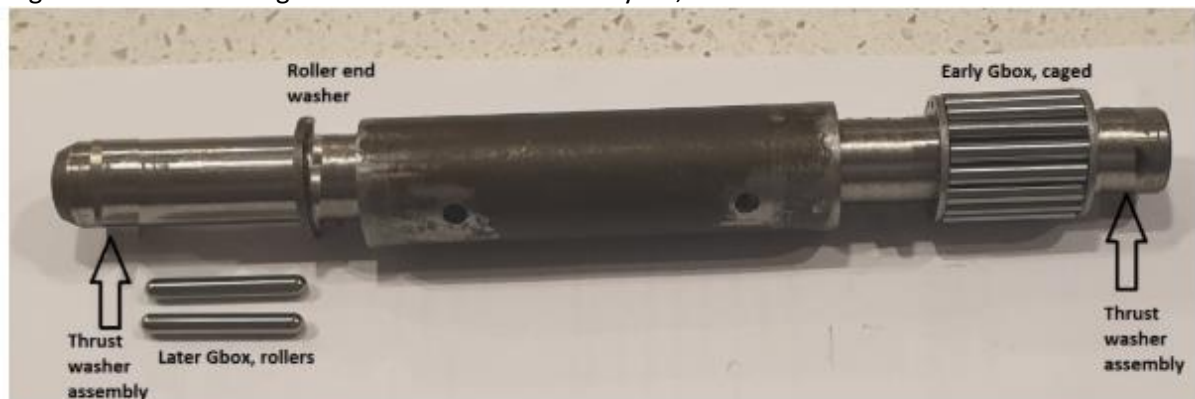
Pic 21

Caged to needle bearing conversion – educational layout, **NOT** as installed

Note: My gearbox had been already converted to a/the later specification ie from the caged needle bearing to just needle rollers.

Basically, the caged bearings can fail. Later gearboxes had the non-caged conversion from the factory, possibly from engine number TPBG1510 (wet clutch to dry clutch) or TPBG2237 ("Gearbox changed internally"). These are listed in the Service Parts List. There are 15 rollers in the cage, replaced by 13 loose ones, these must be larger. To replace the caged frame, you will also need the end washers next to the Spacer Tube [MG735/205] and of course a thrust washer at each end. Blower Pg 179 has a good diagram of the existence of the thrust washers, but with caged bearings. The M12/4SII Parts List also has this. As I had previously owned a M12/4SIII, I had the Parts List. It is invaluable for VA owners.

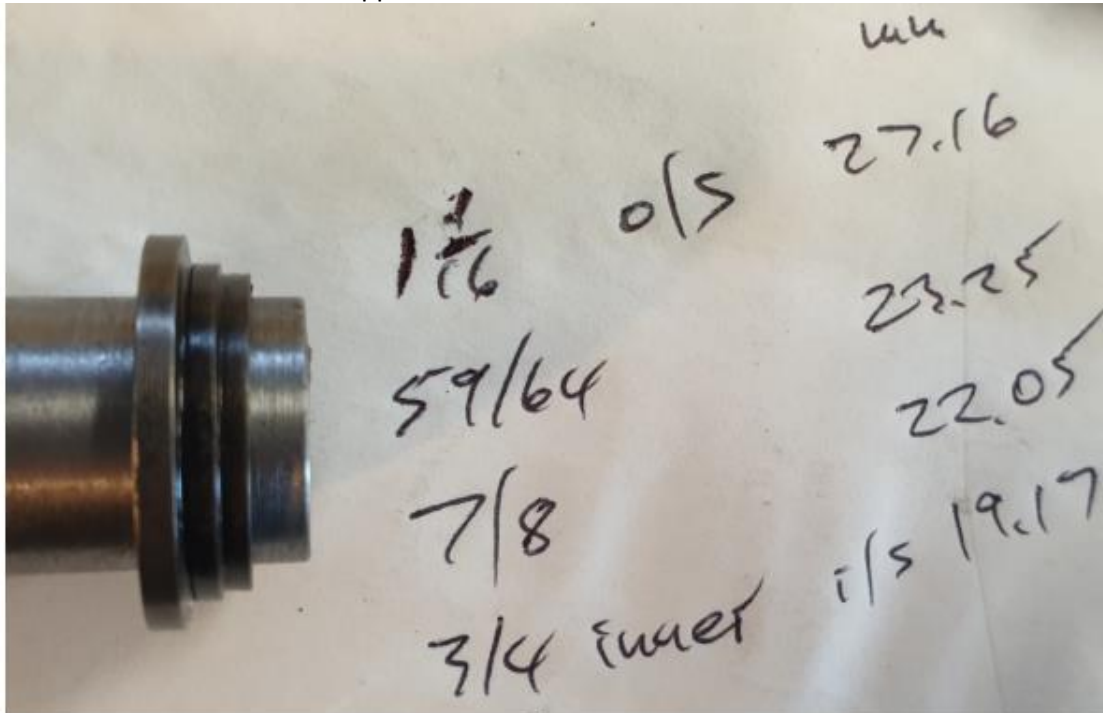
Pic 24

The dimensions of the new stepped washers are

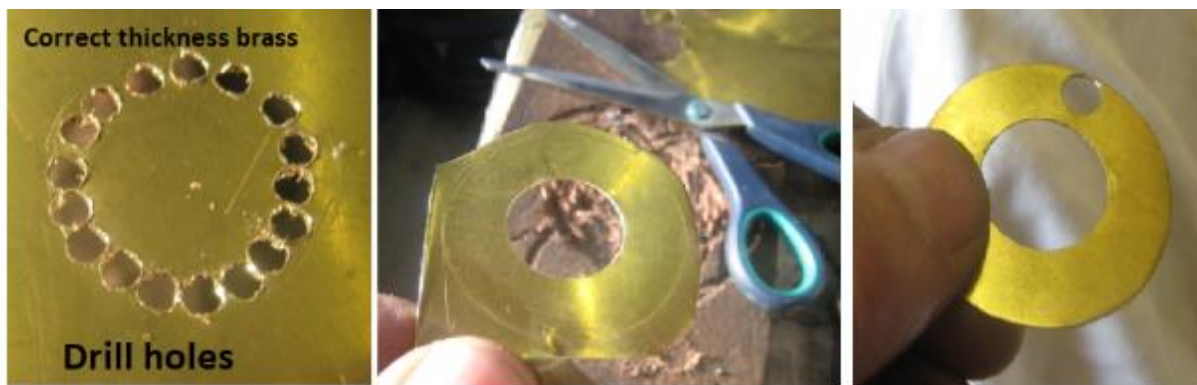
Pic 27

To make two shim washers, each half the thickness required. If necessary, find a local engineer. J Bannister from the SVW Register made them himself and I use his photos below. As I did not have the time, punches or material, I opted to get an engineering firm to do this. A reasonable fit is all that is required as it goes behind the thrust washer and is not a wearing surface.

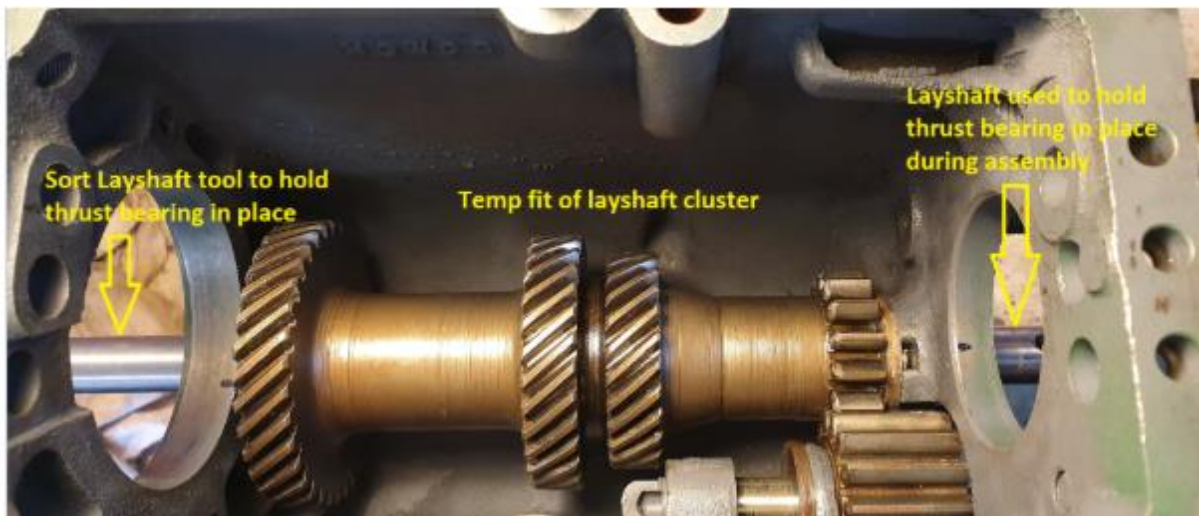
Pic 28

I used the actual layshaft slightly inserted on the hole to hold the rear end rear thrust washers in place but not proud into the gearbox. Measure the thrust washer bearing gap, and change bronze washes/shims as necessary by repeating the process. It does not take long.

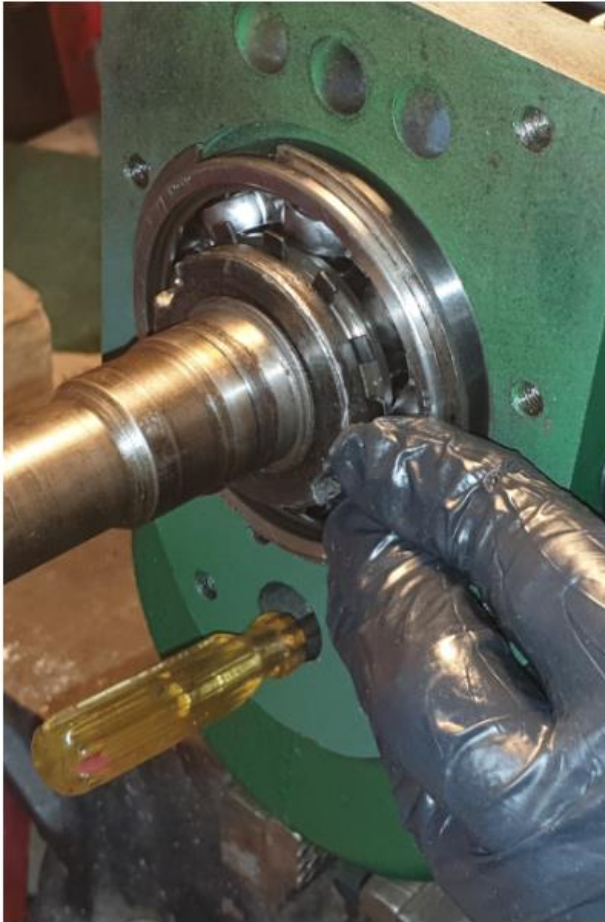
Pic 29

Once the layshaft and thrust bearing are measured and finally assembled push out the original (longer) layshaft. The shorter layshaft tool allows the assembly to stay together as you lower it and rest it at the bottom of the gearbox.

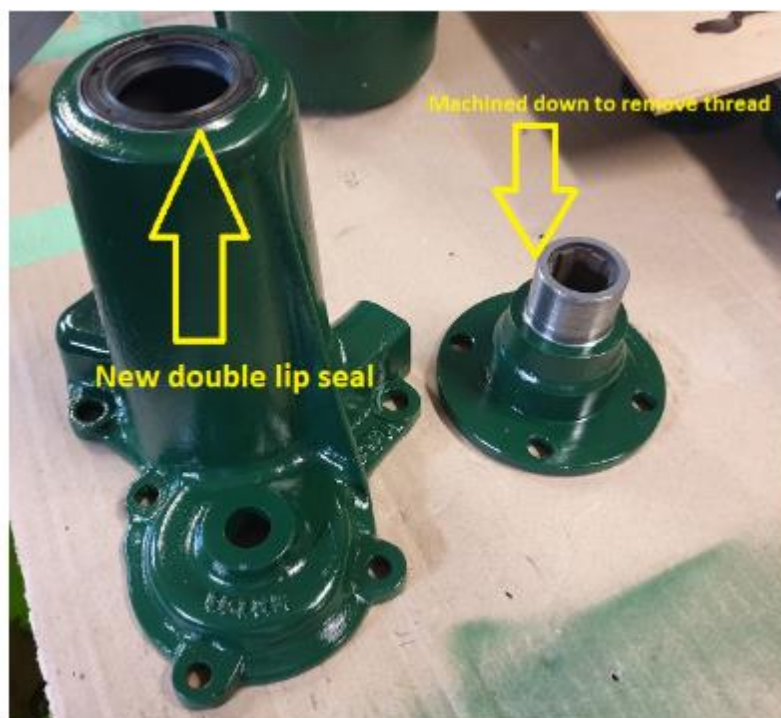
Pic 33

Rear gearbox seal. This is made of felt and picks up the splashed oil at the back of the *gearbox rear cover* [MG735/30] which attached to the *propeller shaft flange* [MG735/259]. It is not obvious and you need to feel around the inside lip to take it out, it is not a seal, just a circle of felt (I cannot find a part number). I took the rear cover and shaft flange to an engineer and he installed a modern double lip seal (see parts number below). He had to lathe the end of the *propeller shaft flange* slightly to remove the oil throwing thread but that did not matter as this now had a smooth surface for the modern double lip seal.

Bell housing [MG735/164] here is another felt seal in the bell housing, I cannot see it is the Service Parts List but it may be X679/63 *Core plug for clutch housing*. I also took this to my engineer and had the seal installed (he said its size was most odd, sort of imperial on the outside and metric on the inner – or the other way around!). He bored out the seal seat and we put in a double lip seal [replacement part number OSI-131-187-43].

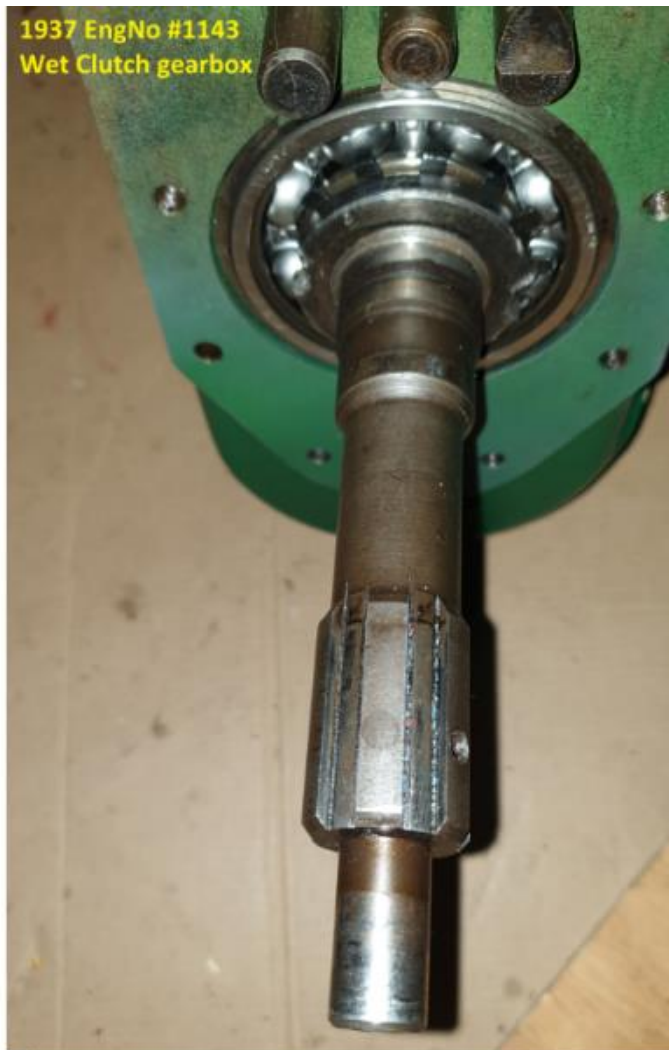
Pic 34

The wet clutch early gearbox (prior to #1510) has a shorter fat spline, later gearboxes from Engine Number #TPMG1510 have longer thinner splines and more of them.
